# **U.S.S. TEXAS (BB-35)**

## **OPTION 5 TANK INSPECTION AND REPAIR ASSESSMENT**

Vessel Survey Report No. 2443

Vessel surveyed: U.S.S. TEXAS (BB-35)

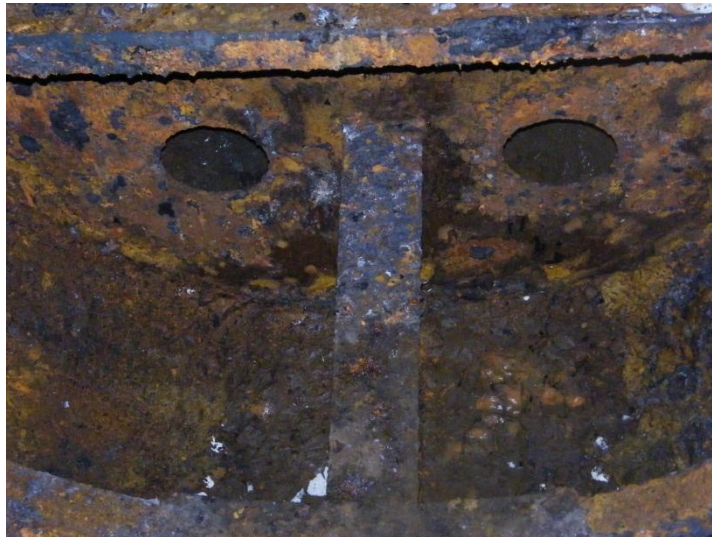
**Figure 5: Keel and Floors in A-41**

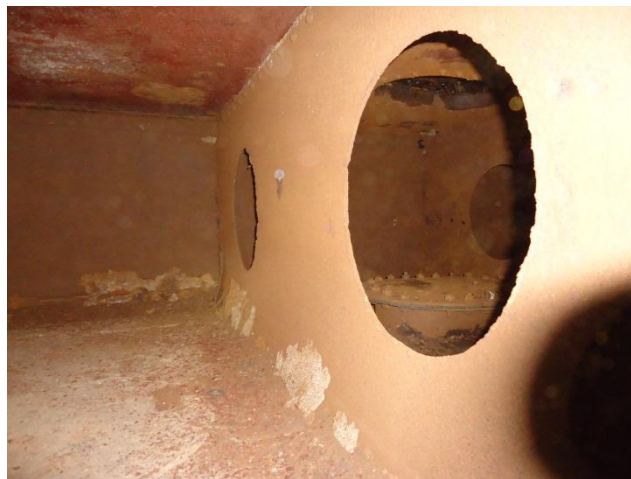
Figure 15: B-2-1-W. Typical Transverse Frame within Tank, Showing Hatch to Inner Bottom

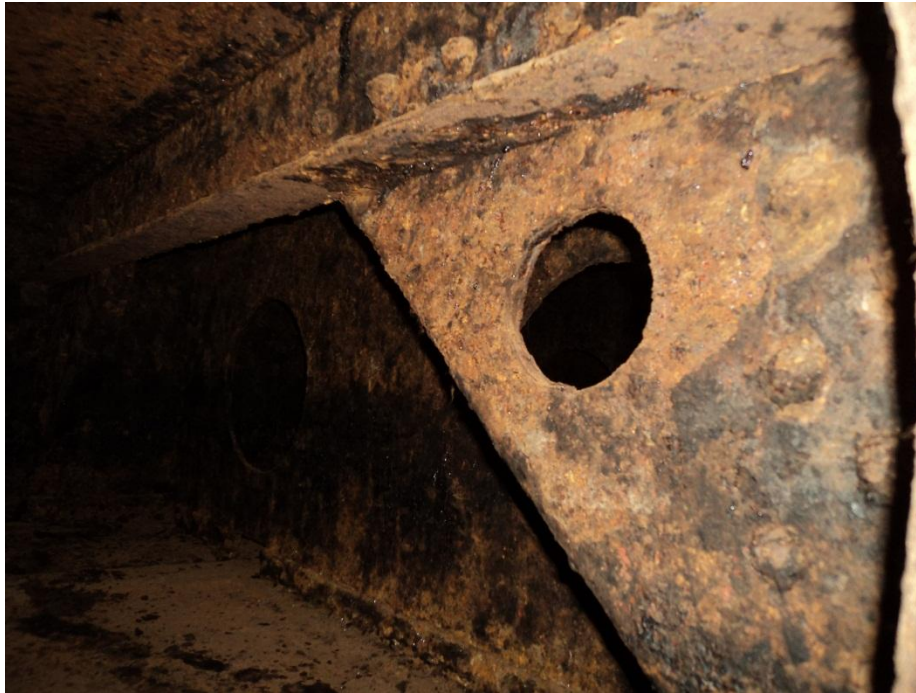
Figure 32: Forward Transverse and Boiler Support Frame within B-3-4-W

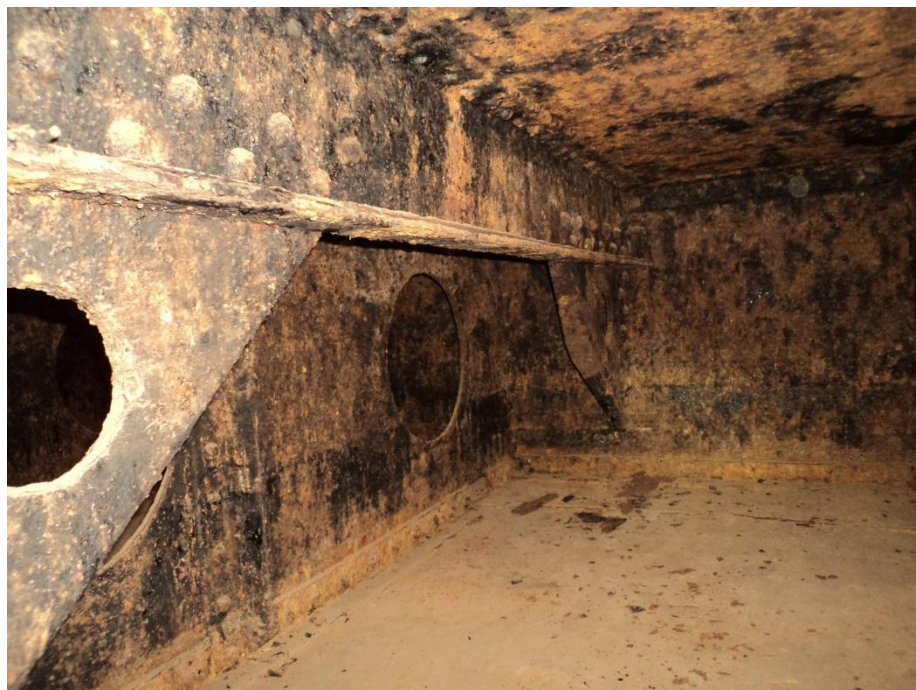
Figure 33: Aft Transverse and Boiler Support Frame within B-3-4-W

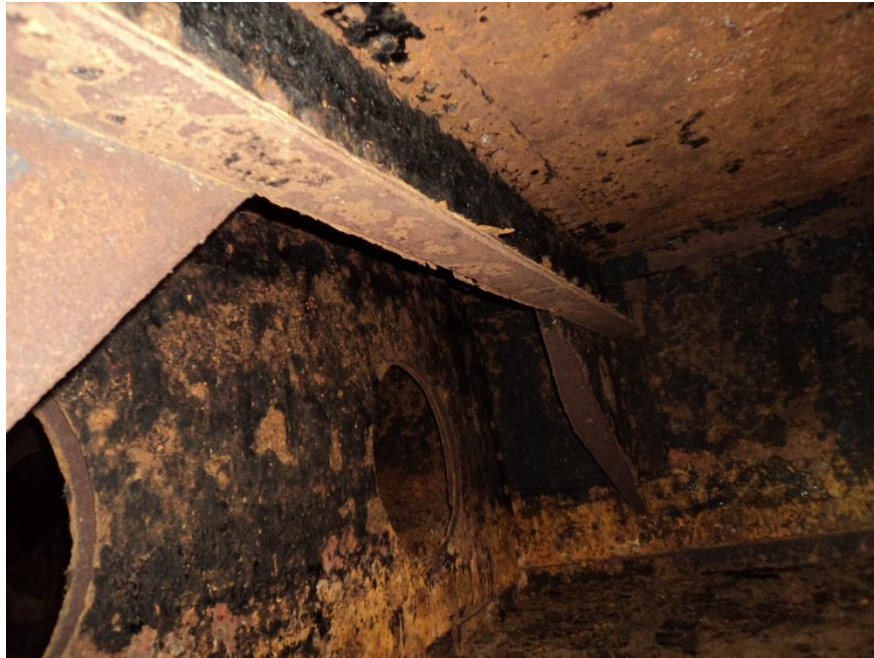
Figure 34: Forward Transverse and Boiler Support Frame within B-3-3-W

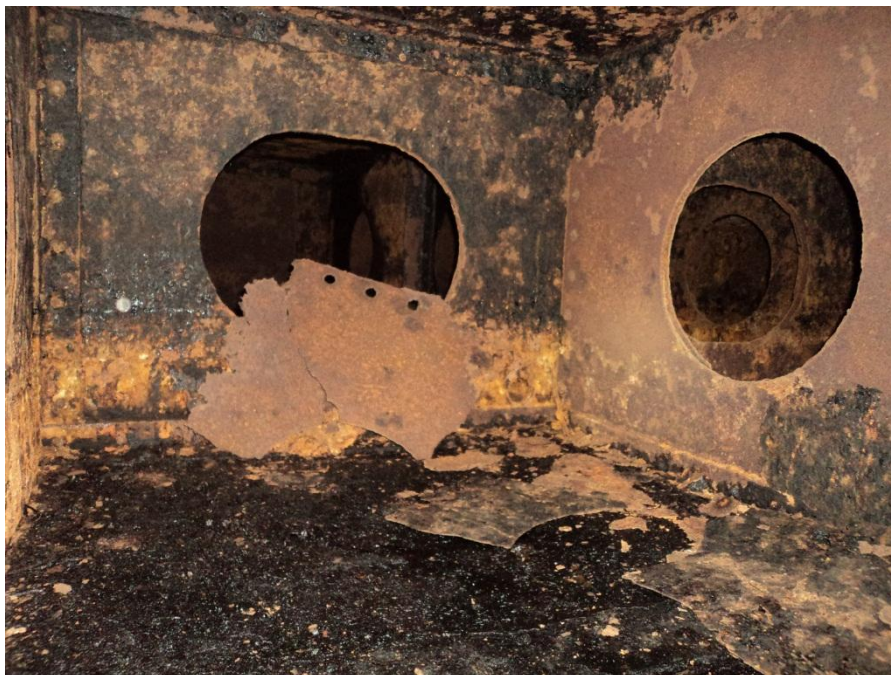
Figure 35: Transverse and Longitudinal Frames within B-3-3-W

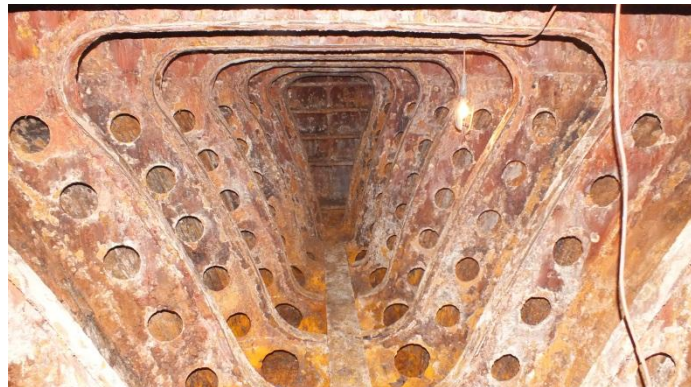
**Figure 71: D-13 Trimming Tank, looking Aft to Stern Casting**

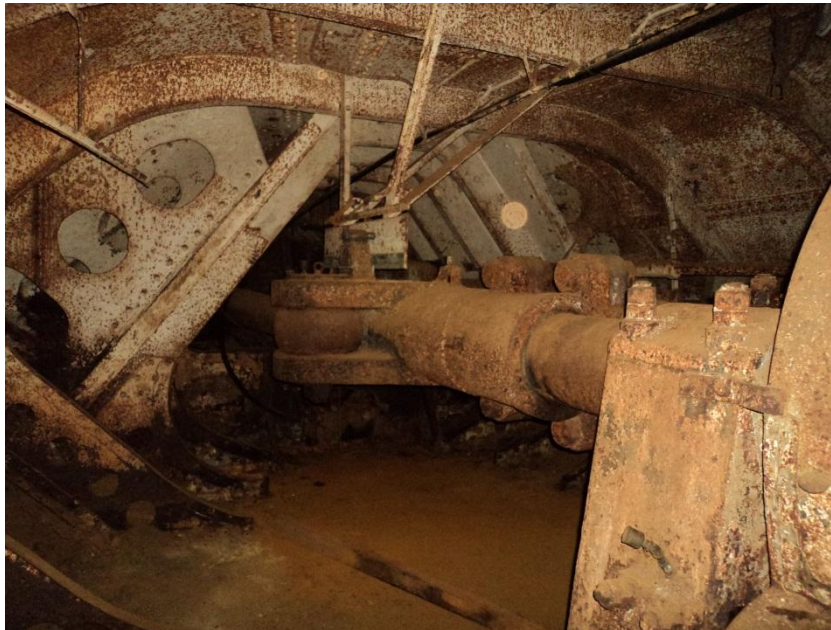
**Figure 73: Heavy Steering Rams and Rudder Post in D-27**

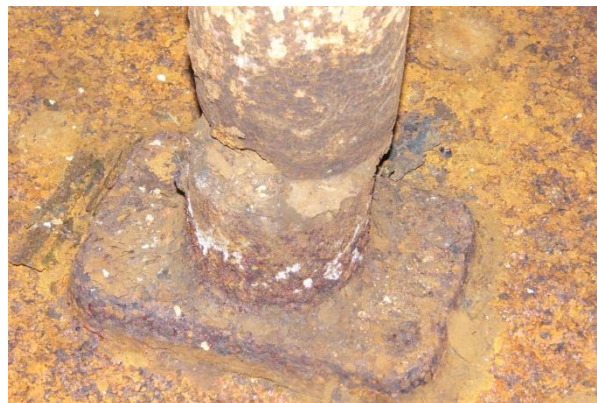
**Figure 87: Wasted Stanchion Base in D-111**

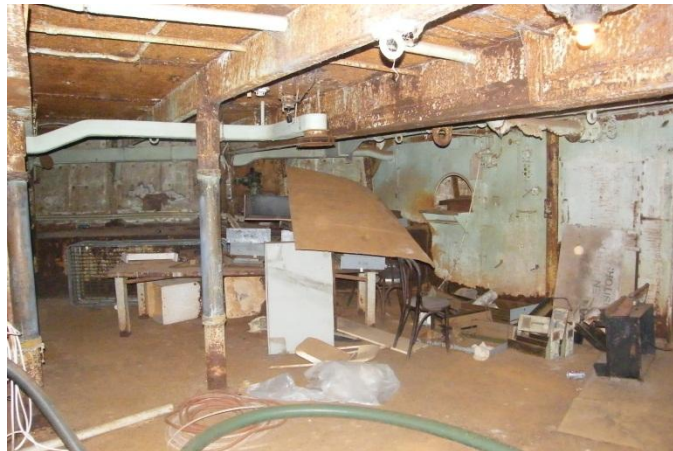
**Figure 88: D-112 CPO Mess Space**

Crop and replace three (3) 5" O.D. x 1/2" wall vertical stanchions in D-112      3 x 5" O.D. x 86" stanchions

Crop out and replace six (6) stanchion bases 1" steel pads in D-111      12 x 1" x 8" x 8" steel pads

Crop out and replace wasted bottom 3' bulkheads at Frame # 137.      150 sq. ft. of 3/8" A-36 plate

Coat all new work with two coats of INTERNATIONAL 300V Primer.

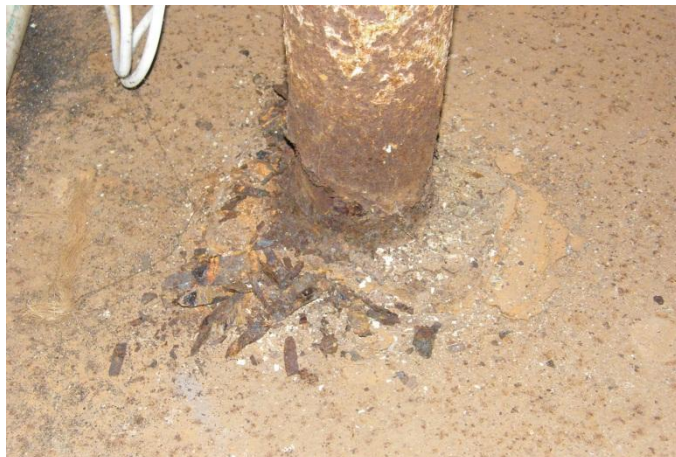
**Figure 89: Wasted Stanchion Base in D-112**

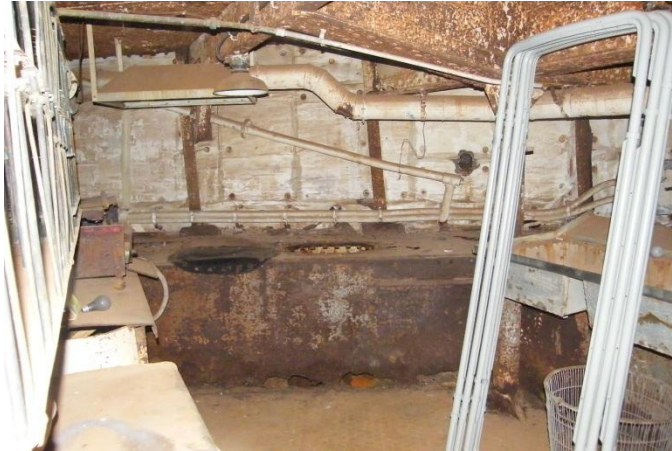
**Figure 90: Looking to Starboard in D-113**

Crop and replace two (2) 5" O.D. x 1/2" wall vertical stanchions in D-113      2 x 5" O.D. x 86" stanchions

Crop out and replace four (4) stanchion bases 1" steel pads in D-113      4 x 1" x 8" x 8" steel pads

Coat all new work with two coats of INTERNATIONAL 300V Primer.

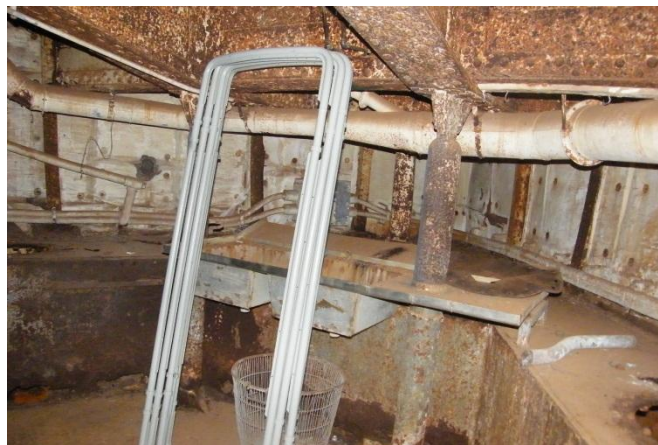
**Figure 91 Looking to Aft in D-113**
